# **FLOOD PLAIN MANAGEMENT**

**A Study Of South Fork  
Shenandoah Tributaries**

**Rockingham County, Virginia**

**QUAIL RUN – BOONE RUN**

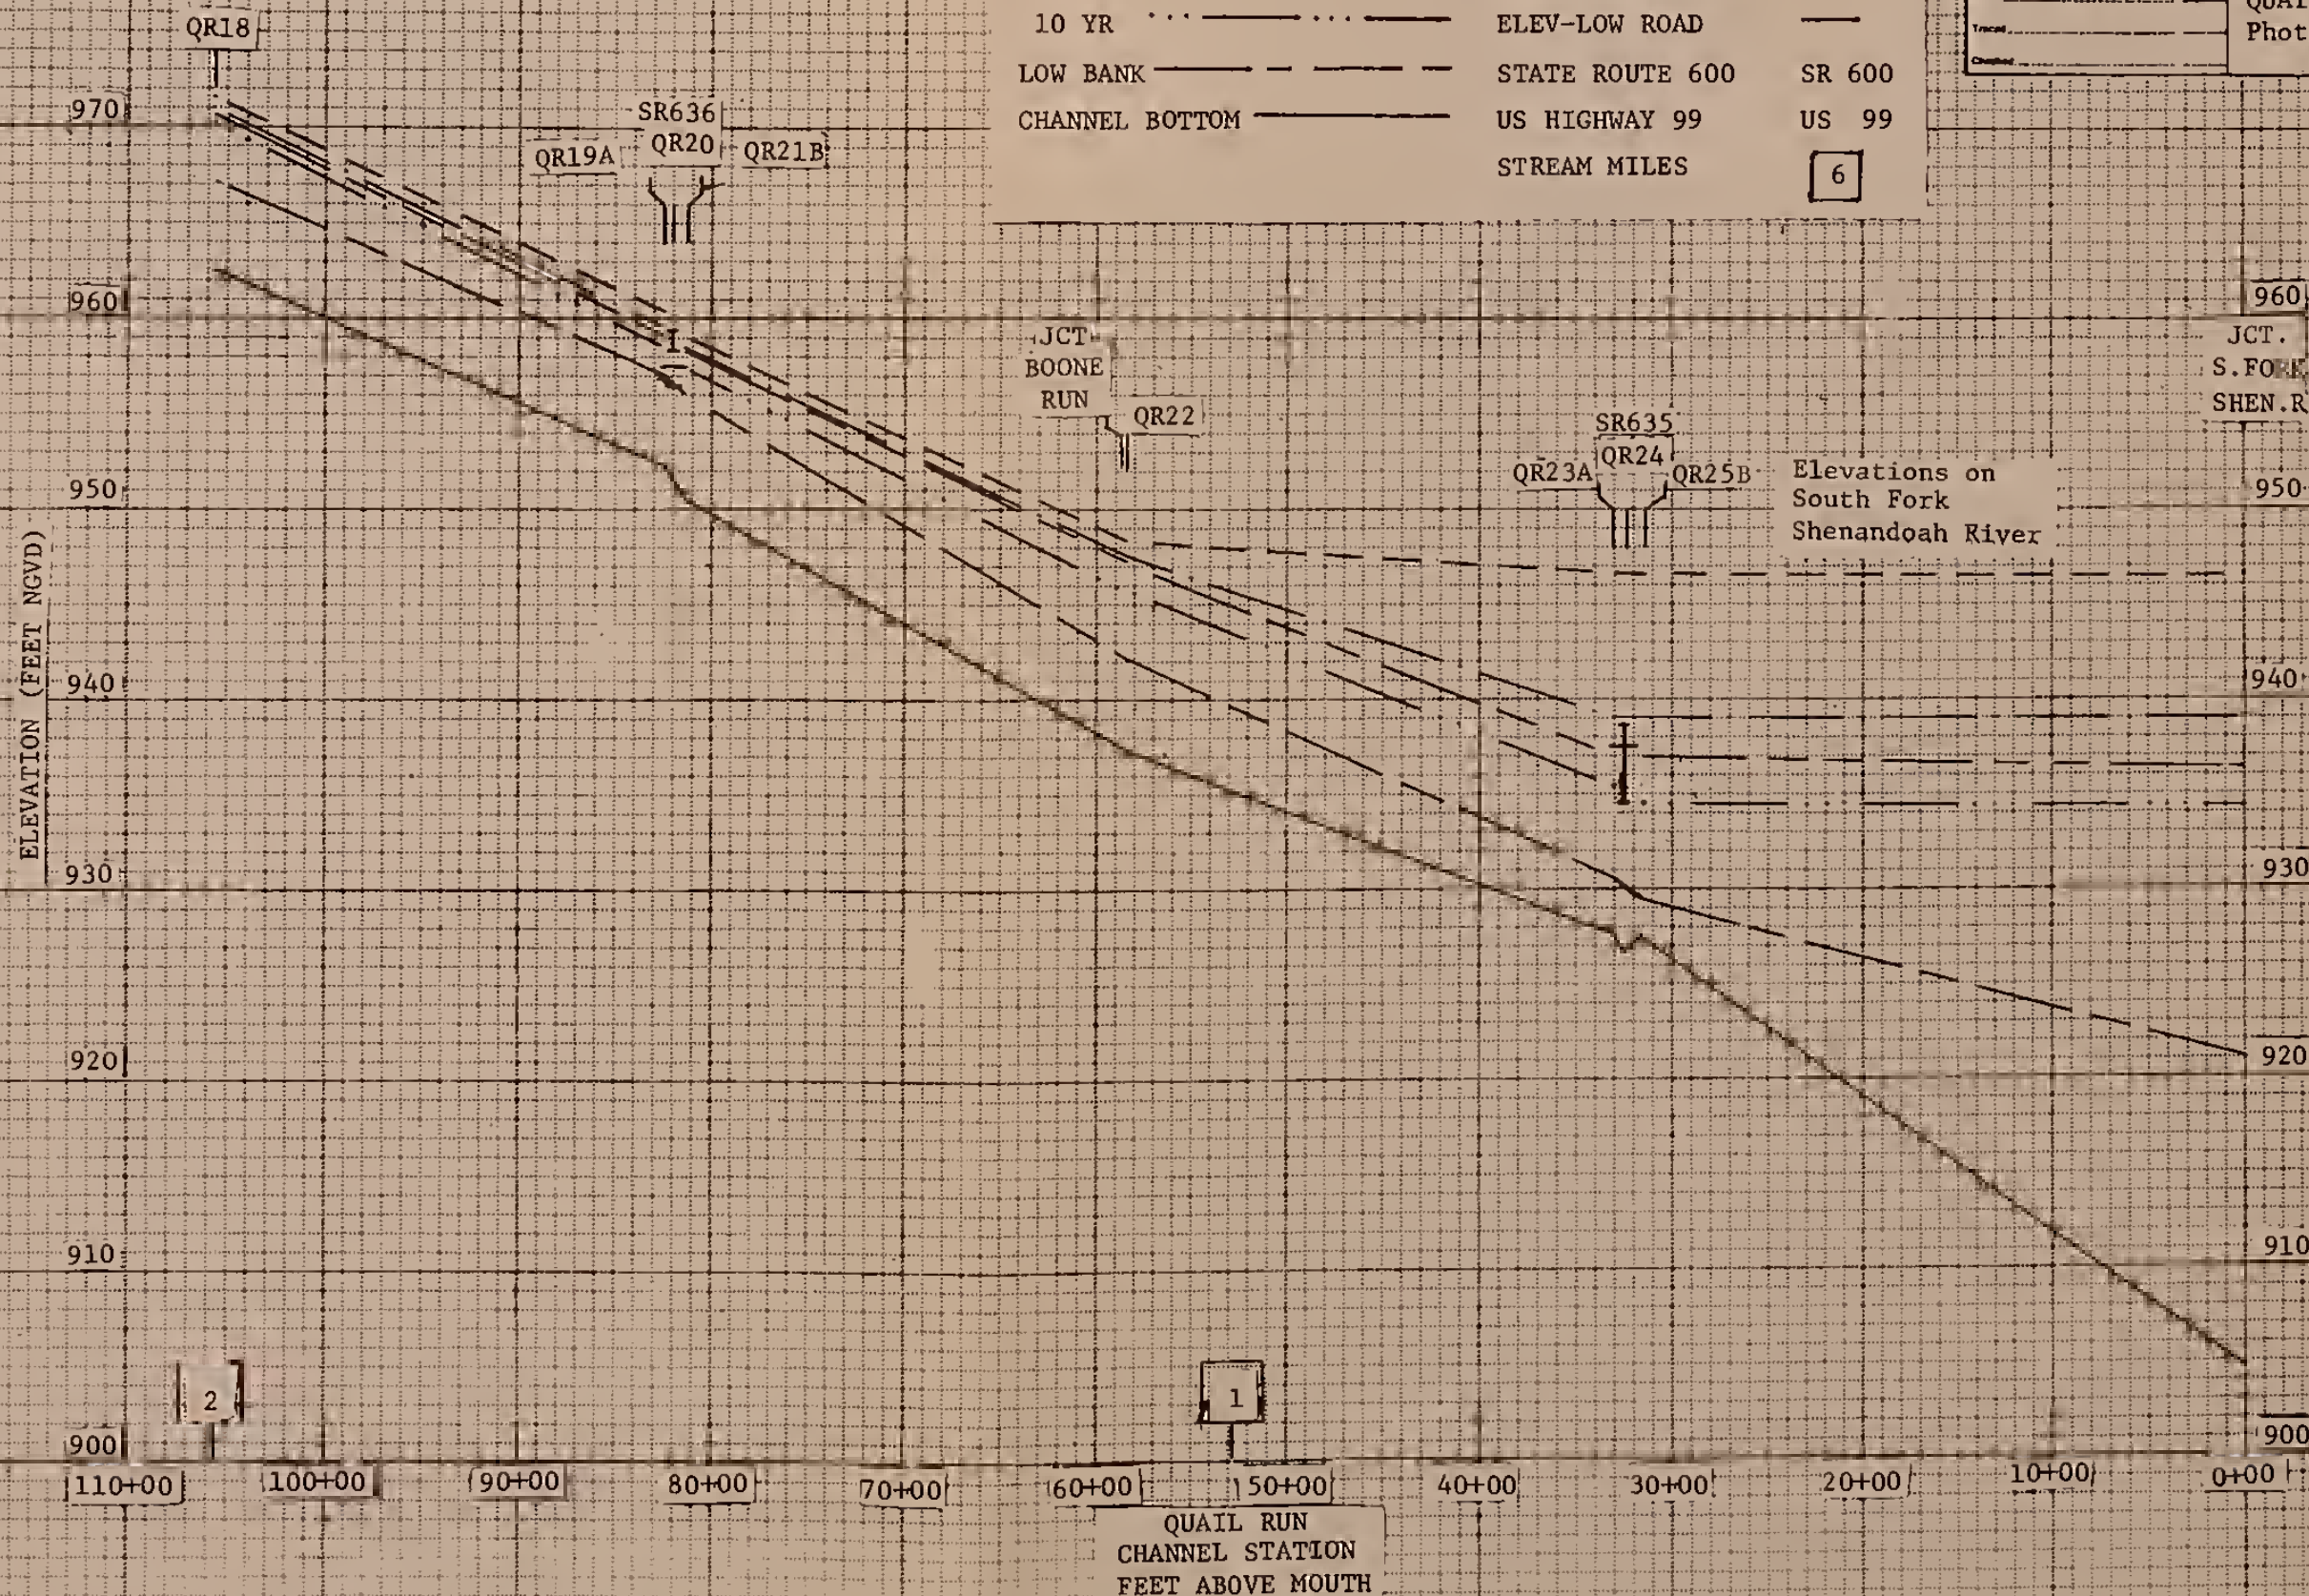
PLATE 3 of 8  
QUAIL RUN -See  
Photomap QR2&3

FLOOD PROFILES  
S FK SHENANDOAH RIVER TRIBS  
ROCKINGHAM COUNTY, VIRGINIA

Flood profile plates provide elevations of the 10, 50, 100 and 500-year floods at any location along the length of the streams. The elevations and discharges of the 10, 25, 50, 100 and 500-year flood at each surveyed cross section are given in Table QR-1. Sample cross sections illustrated how the flood area boundaries were located. Table QR-2 provides the description and elevation of benchmarks which are located on the photomaps.

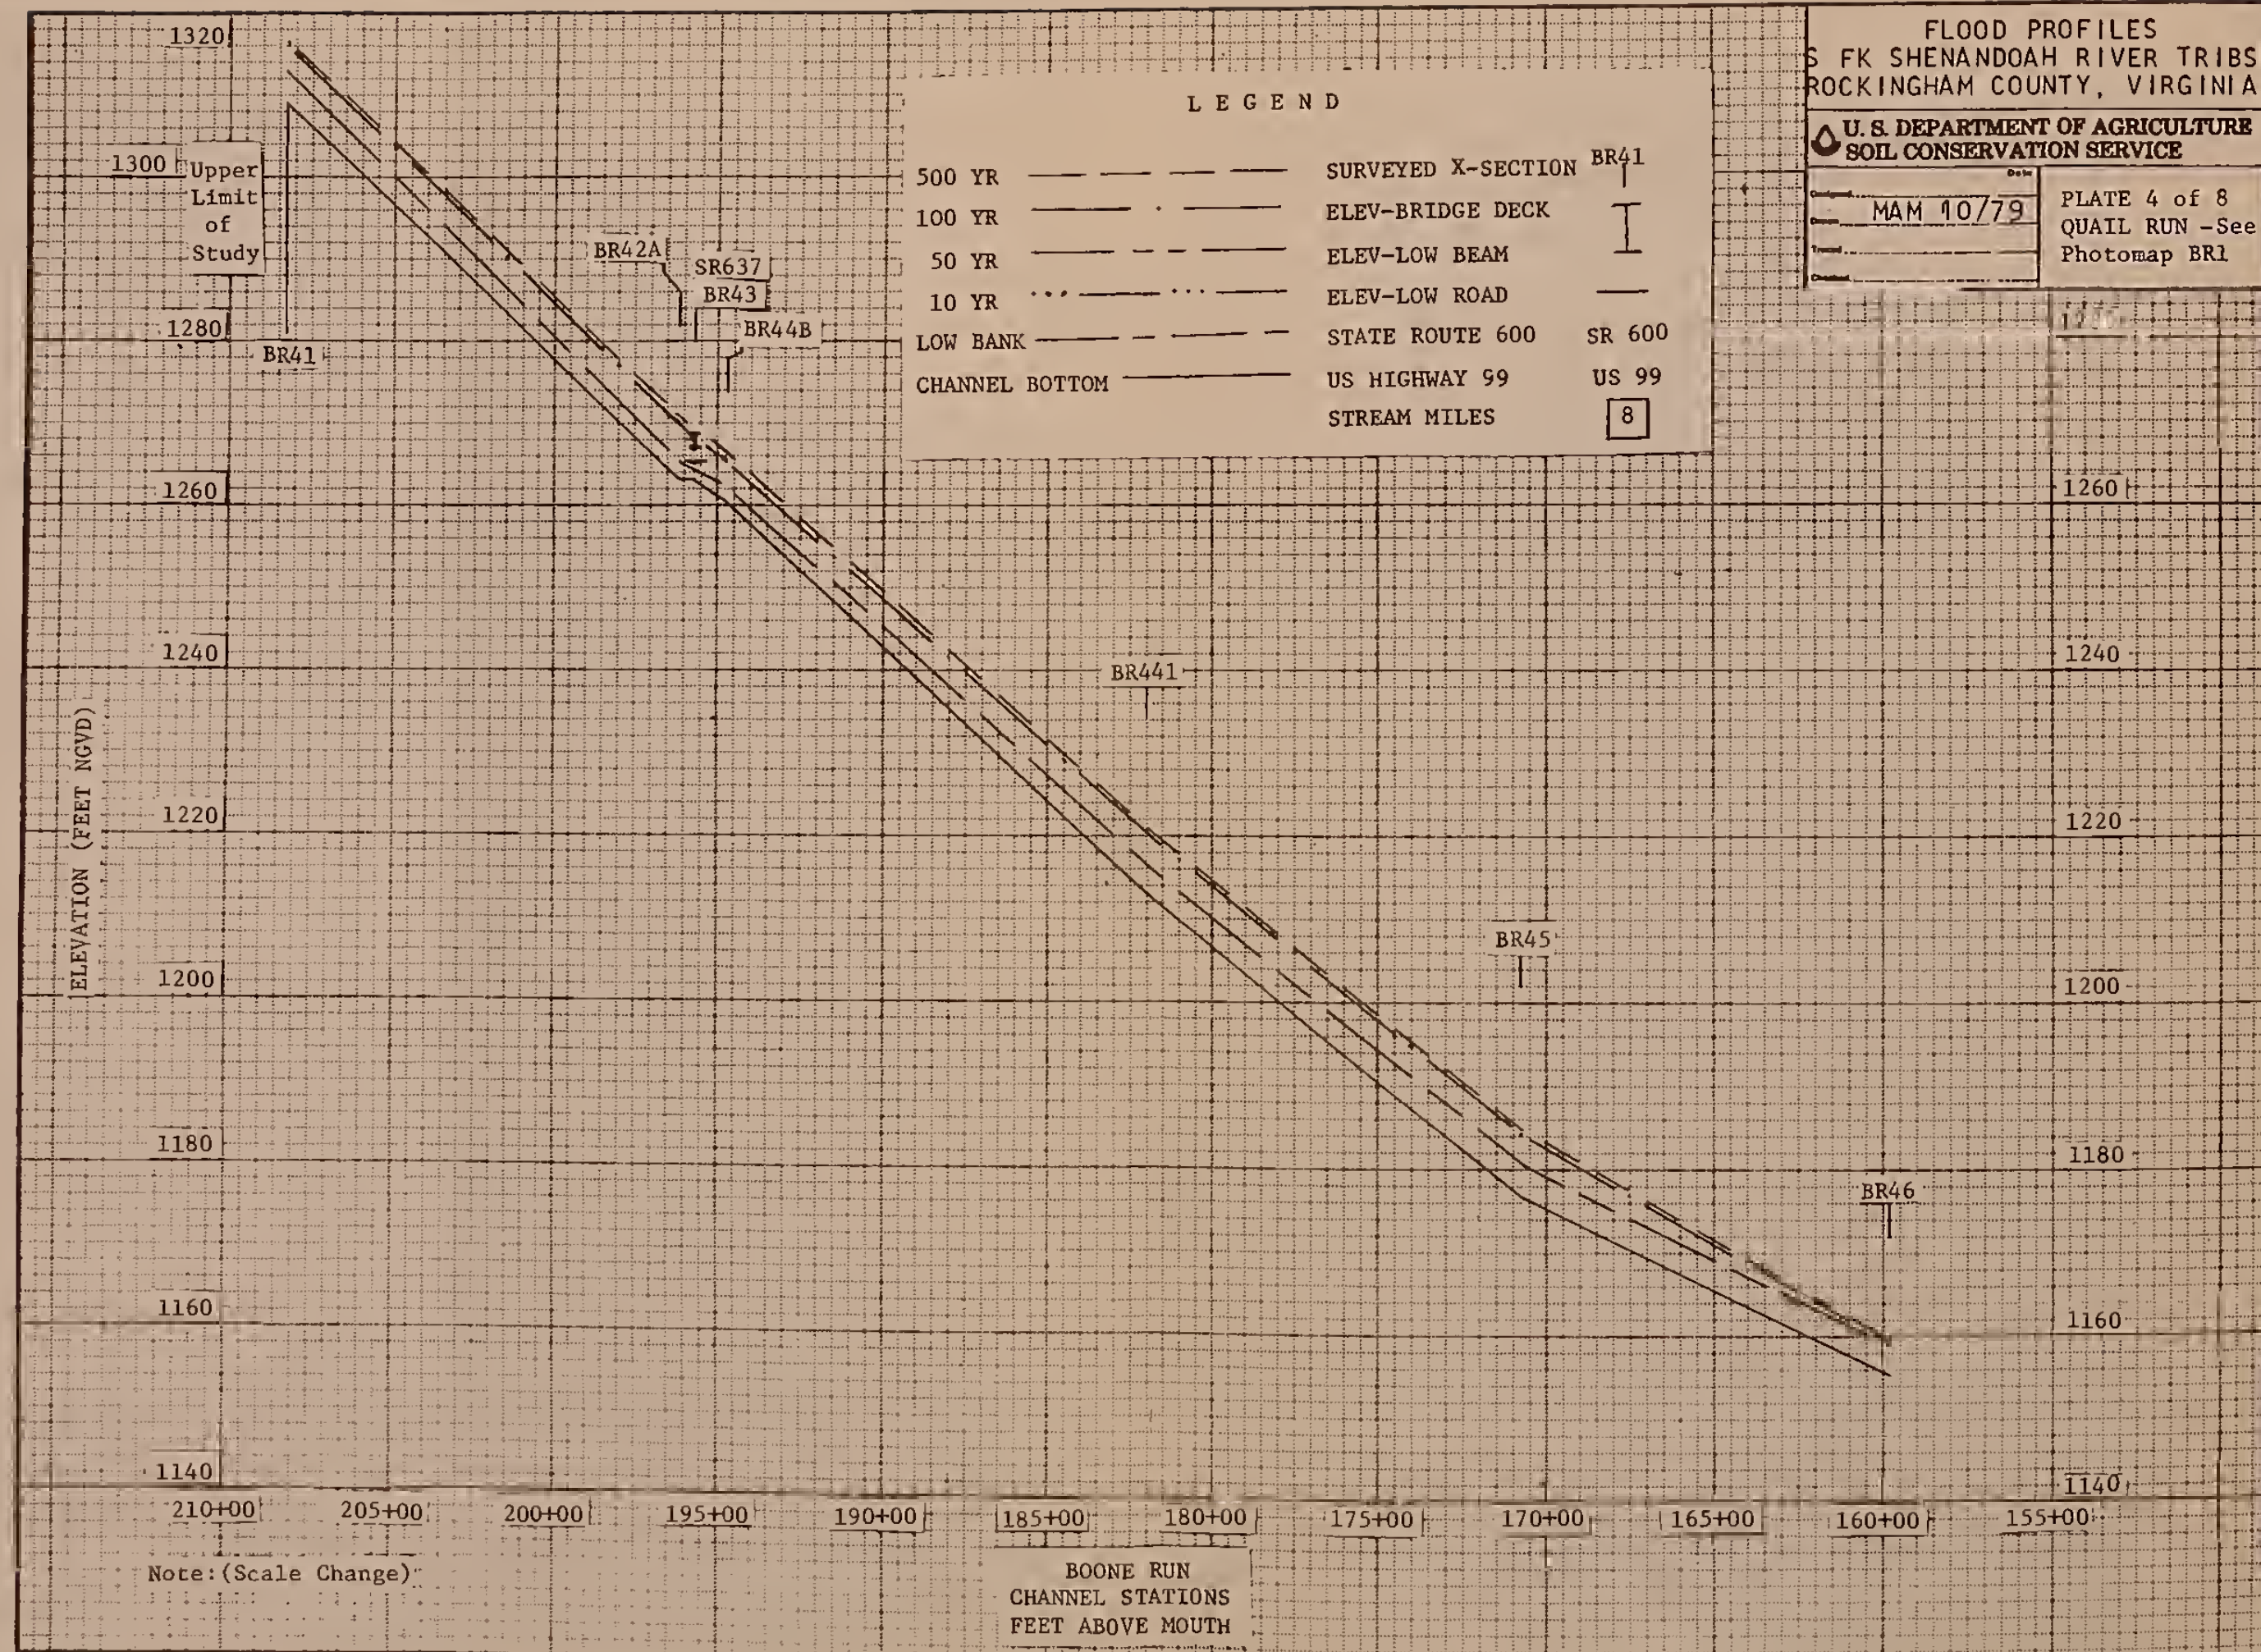
PLATE 4 of 8  
QUAIL RUN - See  
Photomap BR1

FLOOD PROFILES  
S FK SHENANDOAH RIVER TRIBS  
ROCKINGHAM COUNTY, VIRGINIA

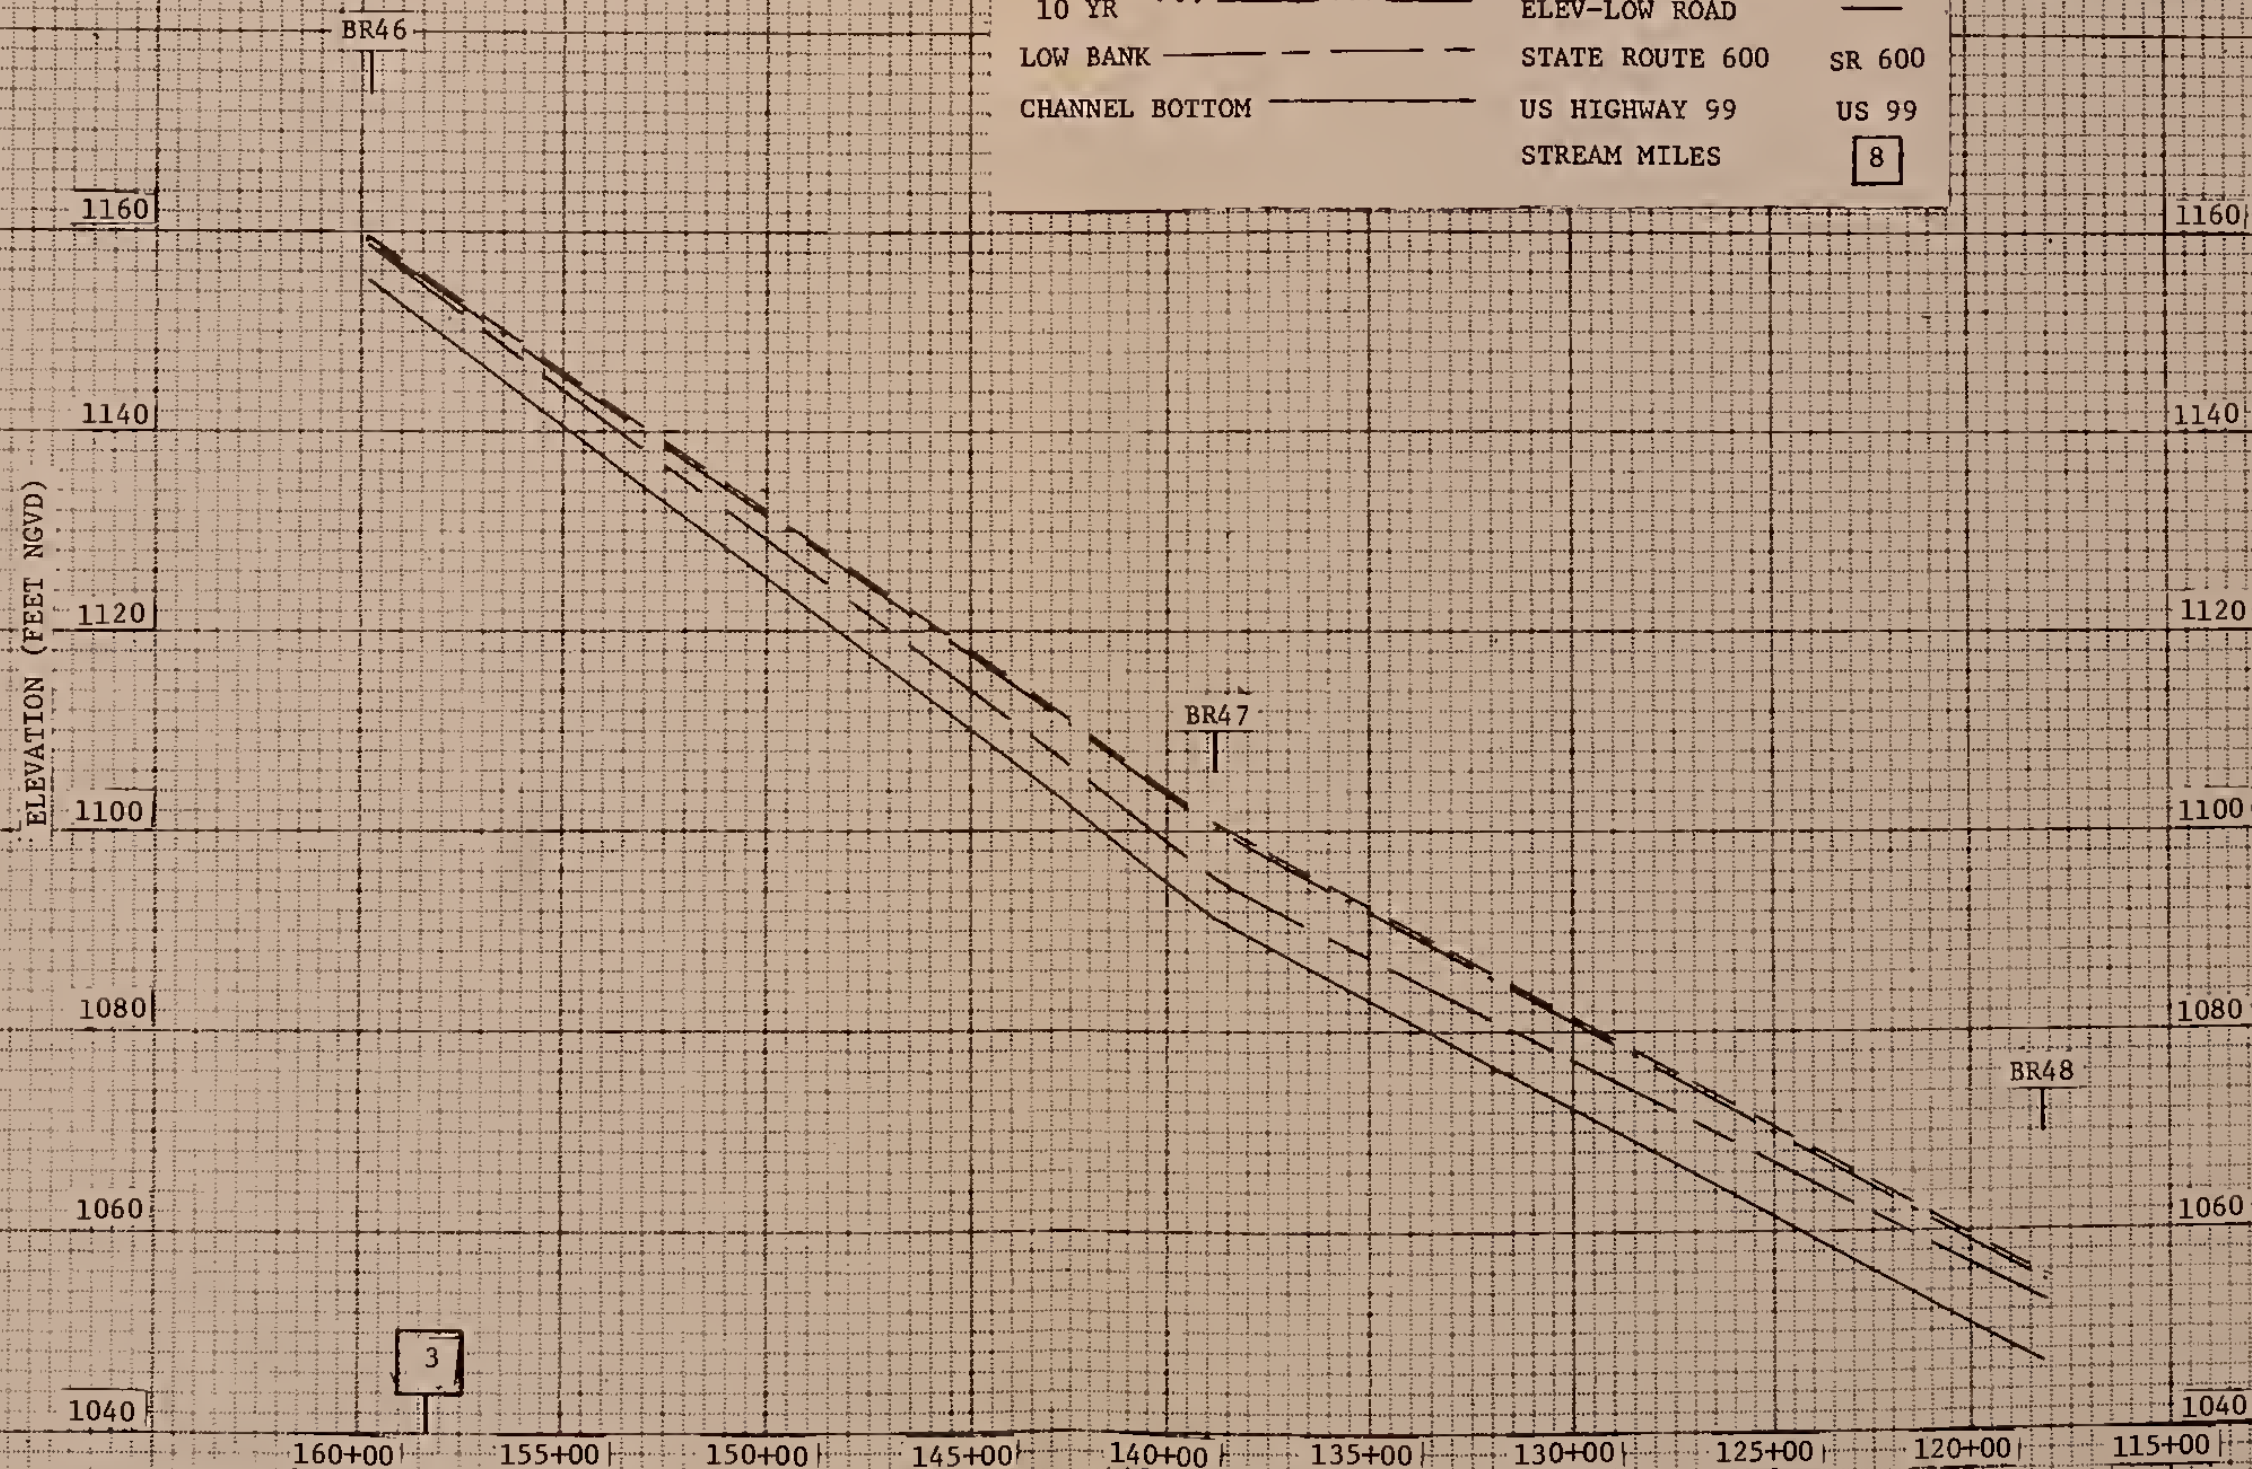
Designed: MAM 10/79 Date: PLATE 5 of 8  
 Drawn: QUAIL RUN - See  
 Traced: Photomap BR1  
 Checked:

BOONE RUN  
CHANNEL STATIONS  
FEET ABOVE MOUTH

FLOOD PROFILES  
 S FK SHENANDOAH RIVER TRIBS  
 ROCKINGHAM COUNTY, VIRGINIA

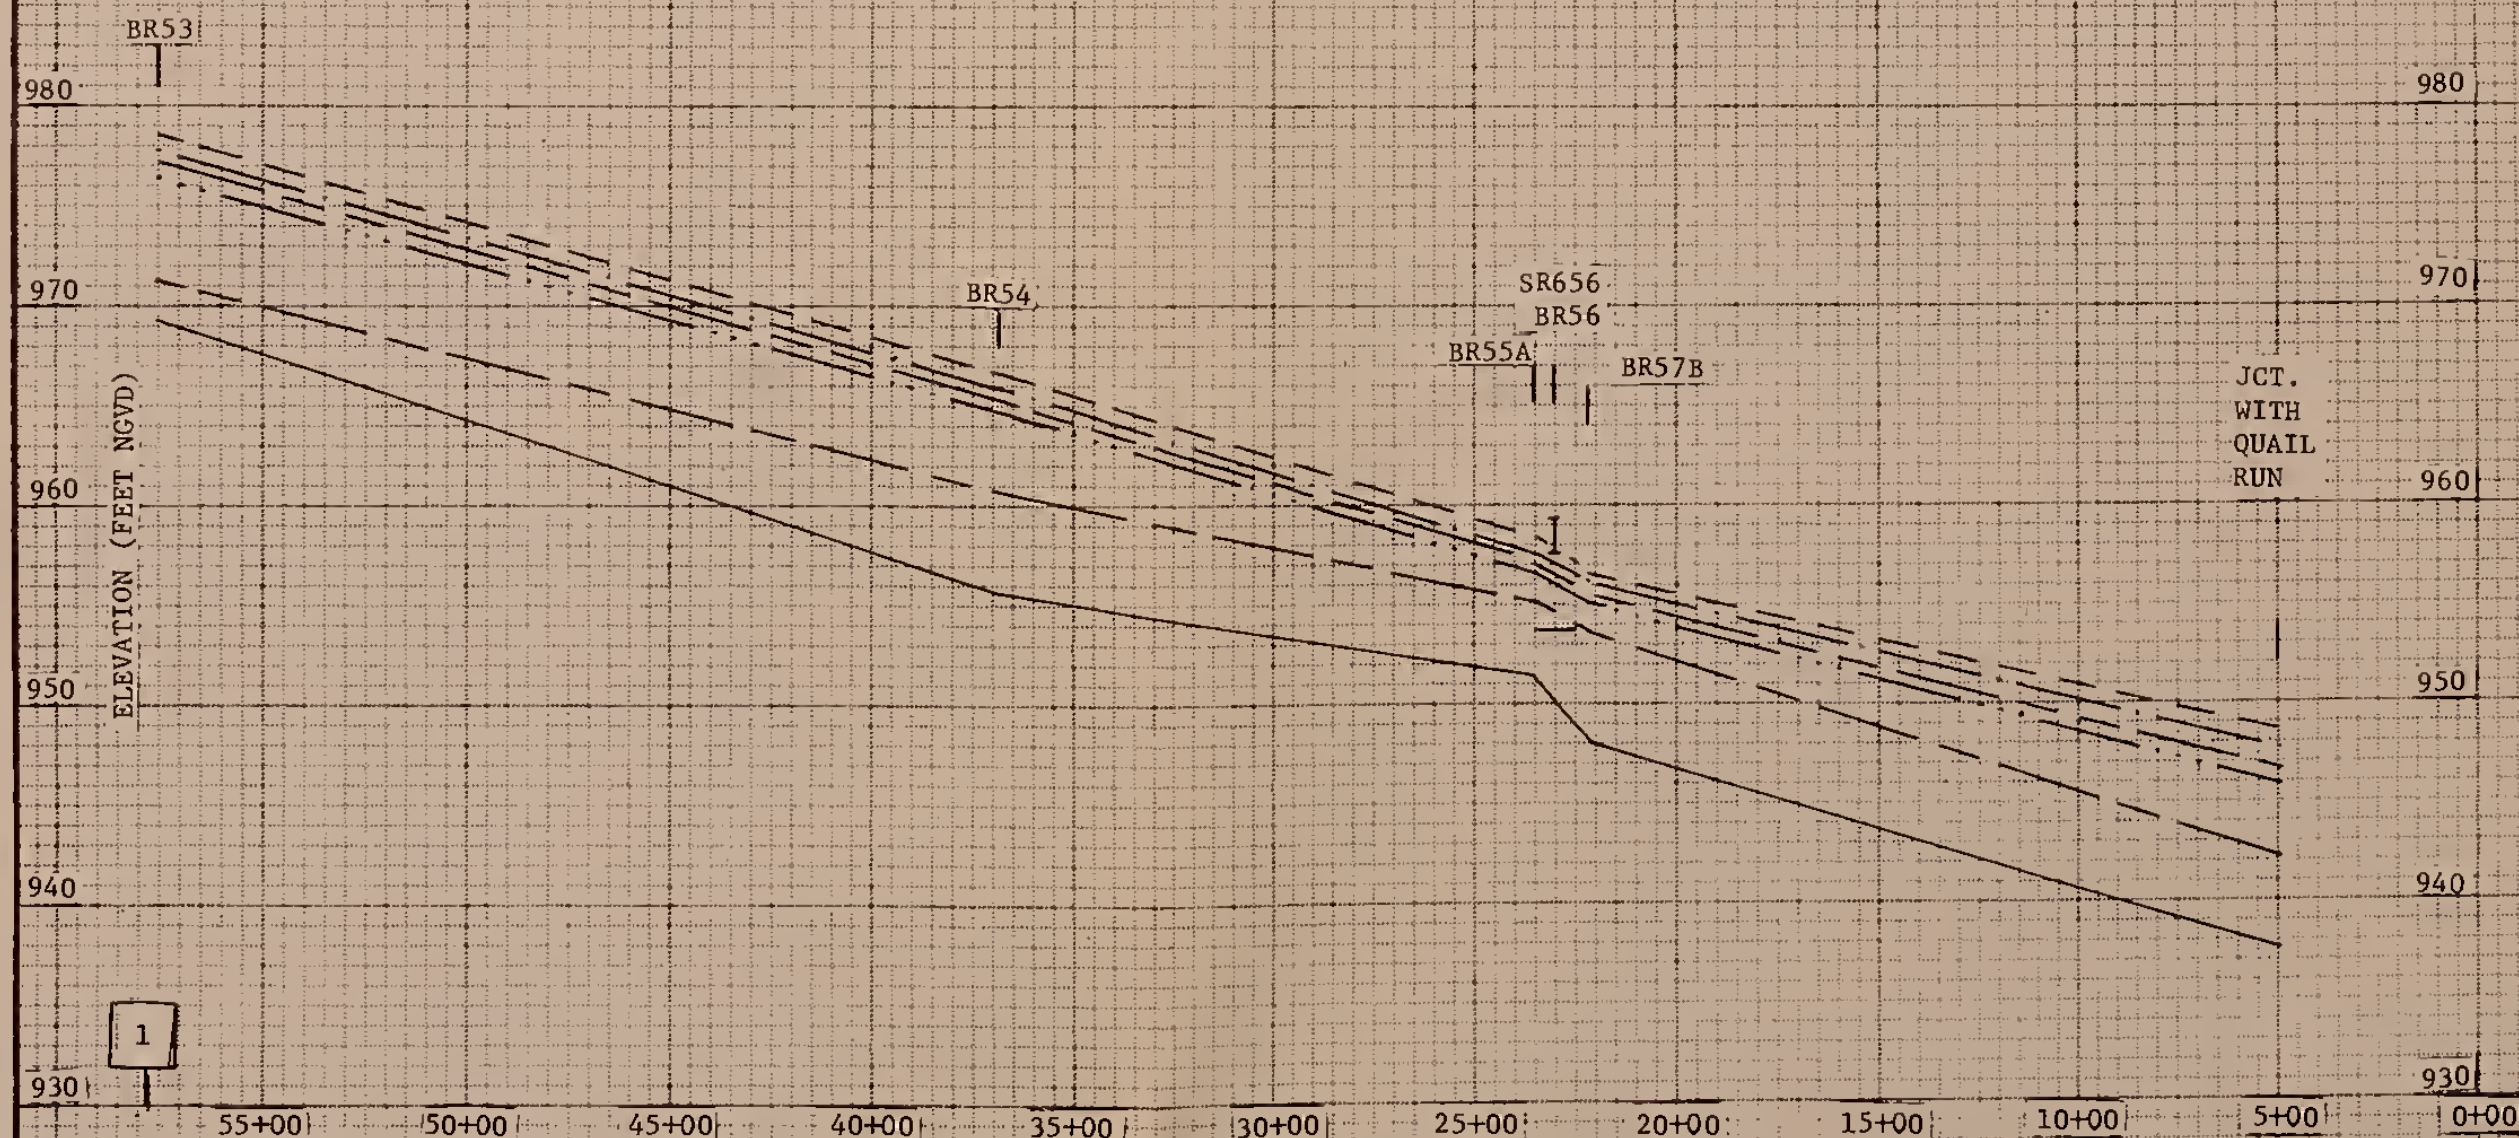
Design: MAM 10779  
Drawn:   
Traced:   
Checked:   
DATE:   
PLATE 7 of 8  
QUAIL RUN -See  
Photomap QR3

BOONE RUN  
CHANNEL STATIONS  
FEET ABOVE MOUTH

FLOOD PROFILES  
S FK SHENANDOAH RIVER TRIBS  
ROCKINGHAM COUNTY, VIRGINIA

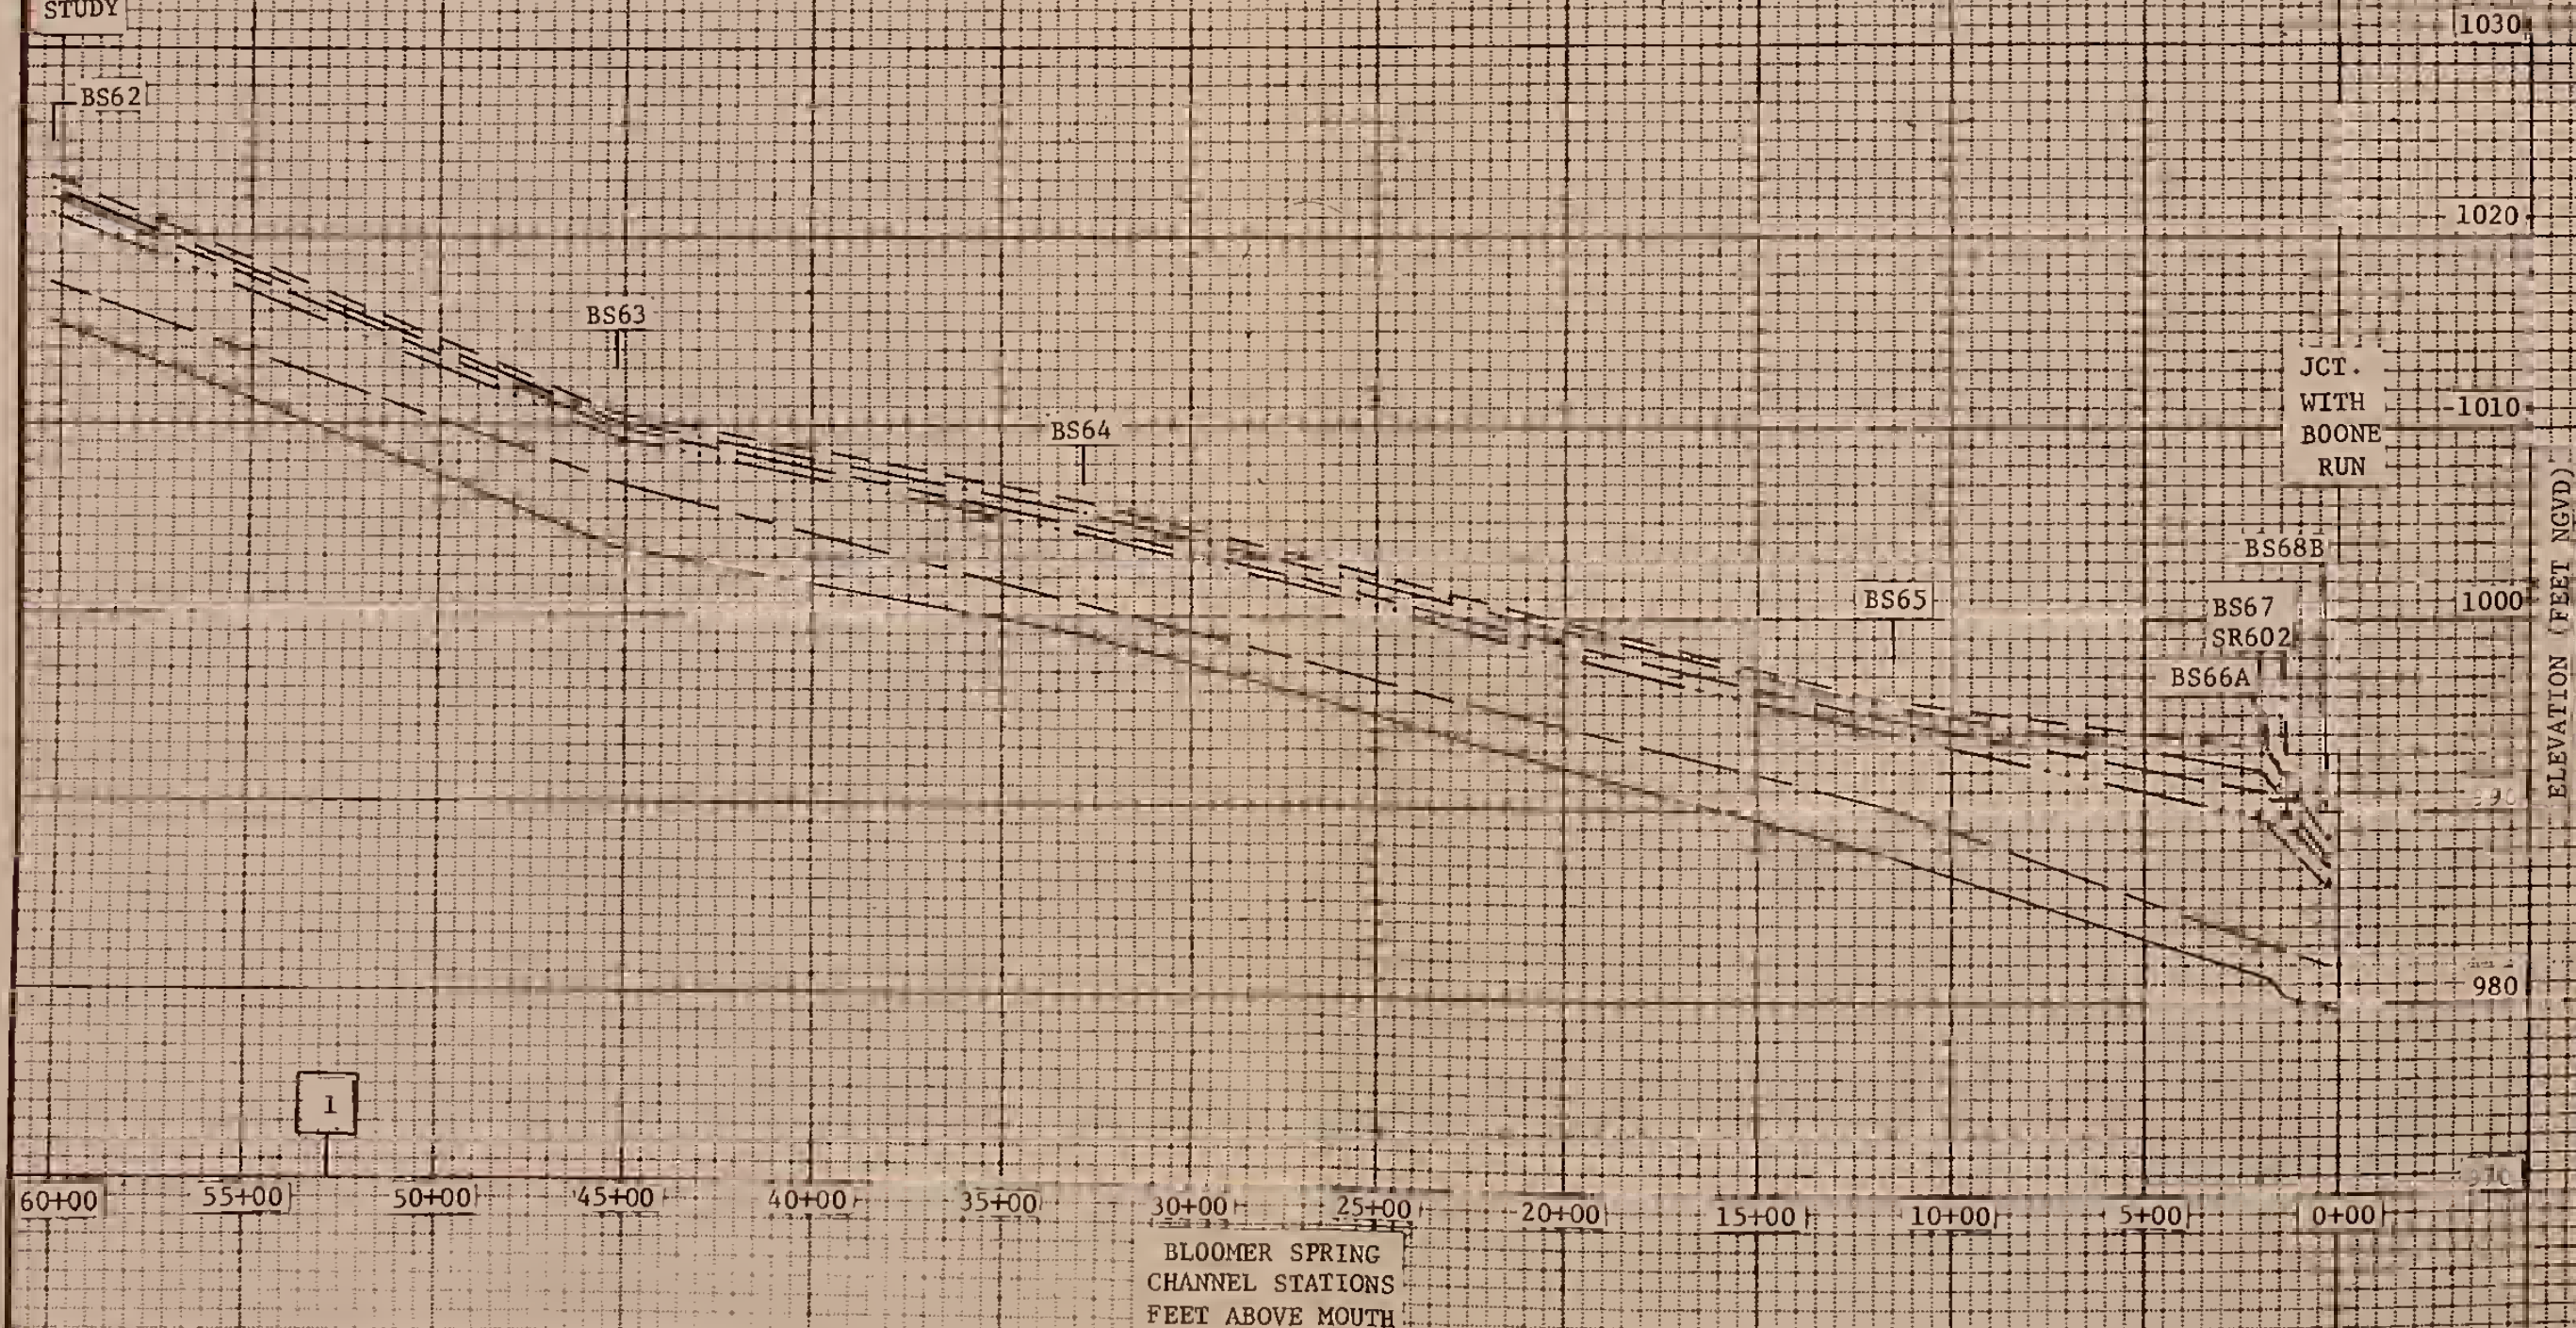
Date: MAM 10/79  
Plate 8 of 8  
QUAIL RUN-See  
Photomap BRI

BOONE RUN  
CHANNEL STATIONS  
FEET ABOVE MOUTH

FLOOD PROFILES  
S FK SHENANDOAH RIVER TRIBS  
ROCKINGHAM COUNTY, VIRGINIA

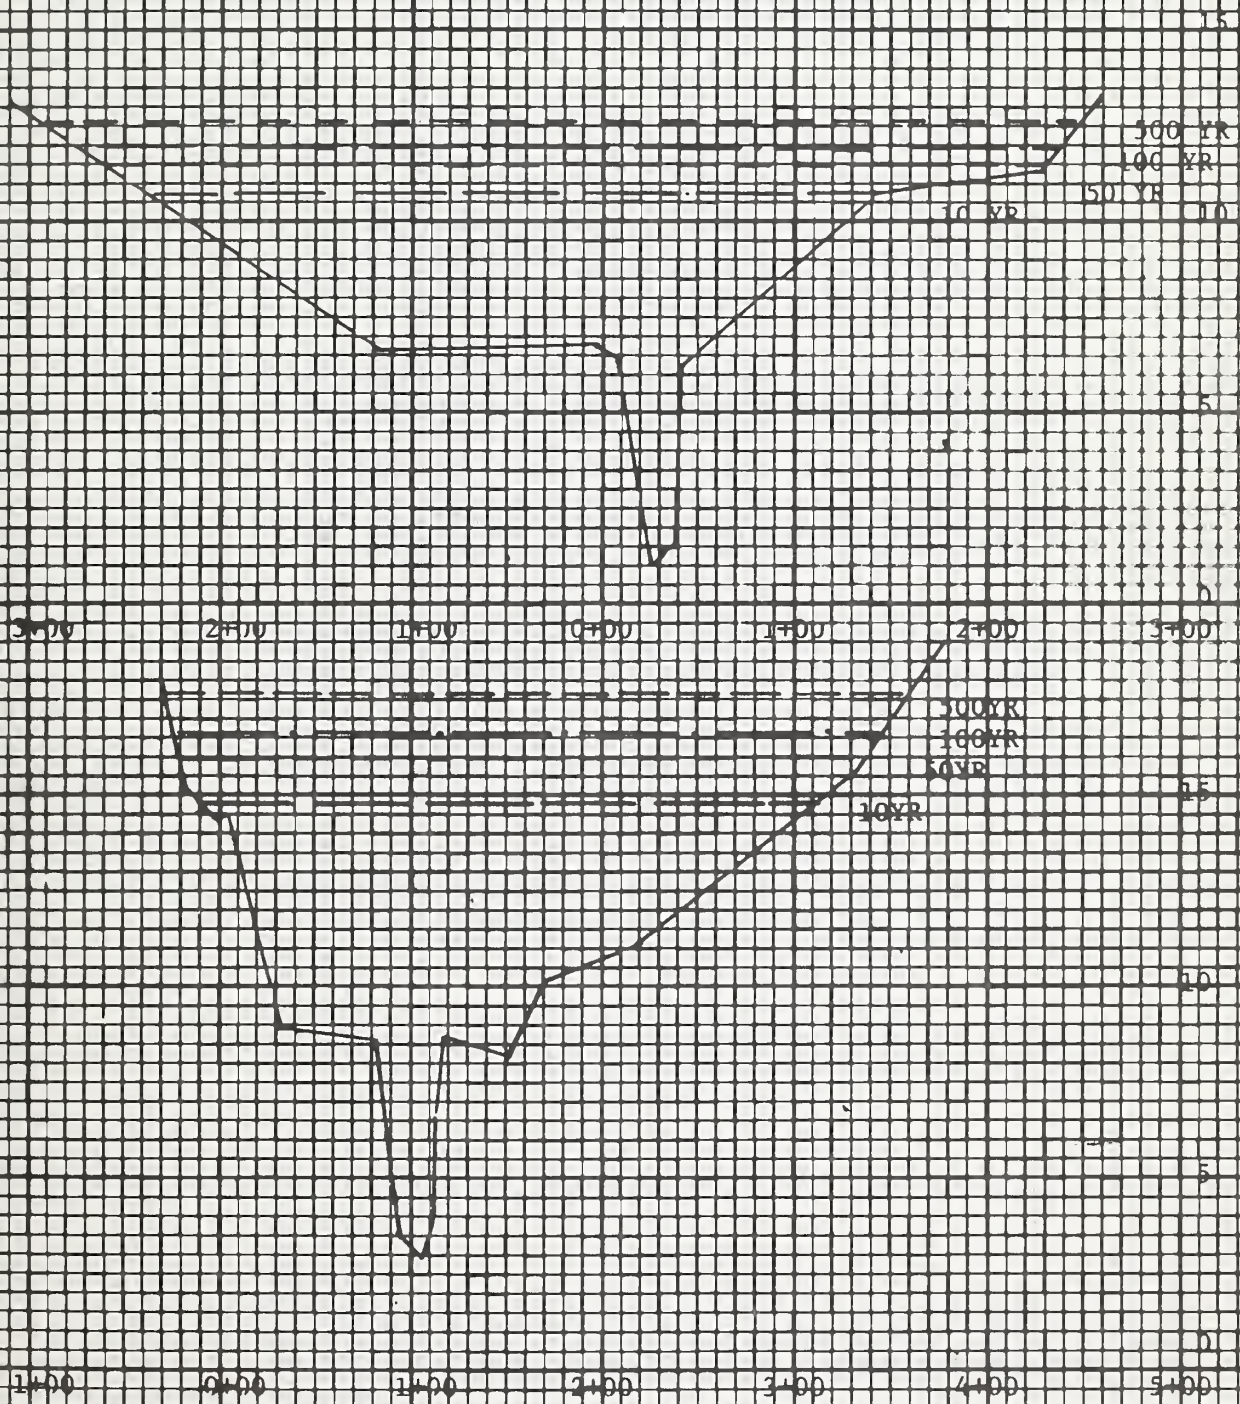
# TYPICAL CROSS SECTIONS
